## No leakage from the sunken nuclear submarine K-159

In 2014 a joint Norwegian Russian expedition visited the site of the sunken nuclear submarine K-159 in the Barents Sea. No indication of any leakage from the reactor units of K-159 to the marine environment was detected. Due to the potential for contamination, further monitoring of the submarine is warranted.

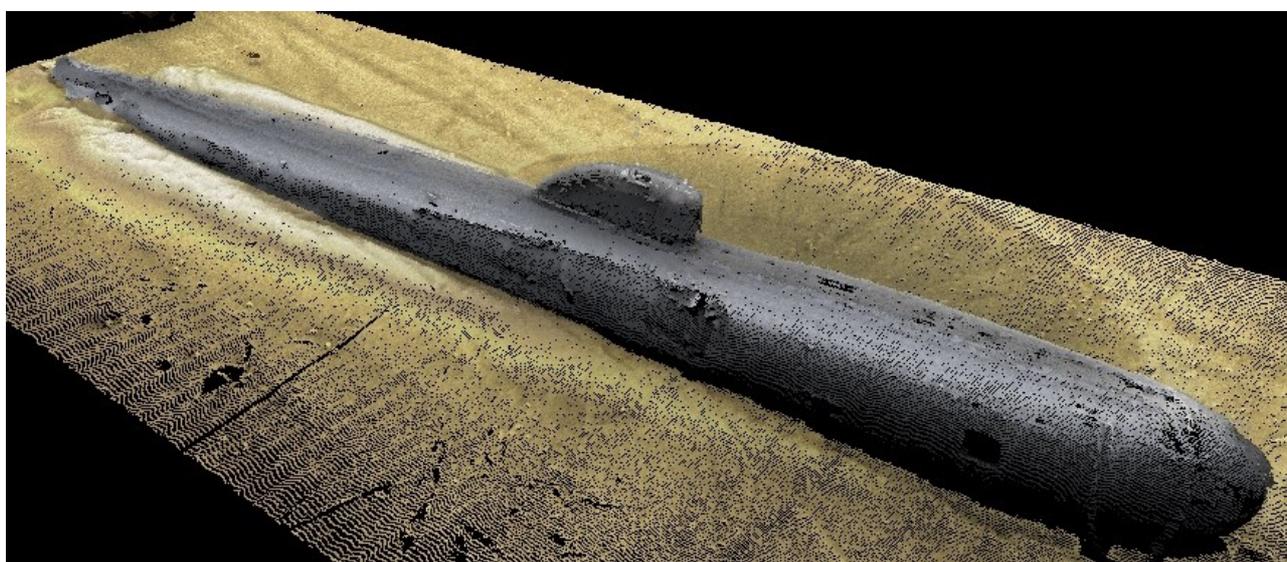
Sonar image of K-159 from 2007 (Photo: ADUS DeepOcean and Salvage & Marine Operations (S&MO) of the UK MOD)
