Investigation into the Radioecological Status of the sunken Nuclear Submarine Komsomolets in the Norwegian Sea

Results from the 2019 Norwegian research cruise

This report presents the results obtained by the Norwegian research cruise in 2019 to the site of the sunken nuclear submarine Komsomolets in the Norwegian Sea.

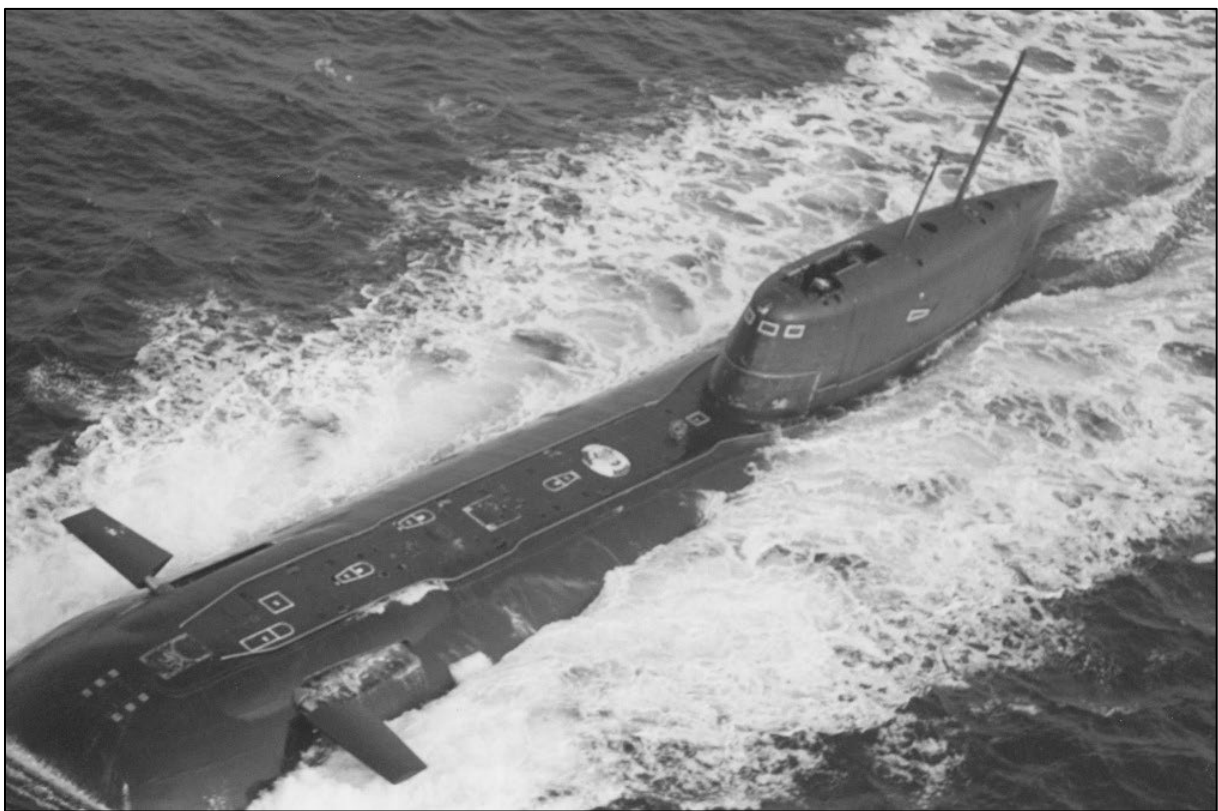
Figure 1.3. The nuclear submarine Komsomolets in service (Photo: Norwegian Air Force 333 Squadron).

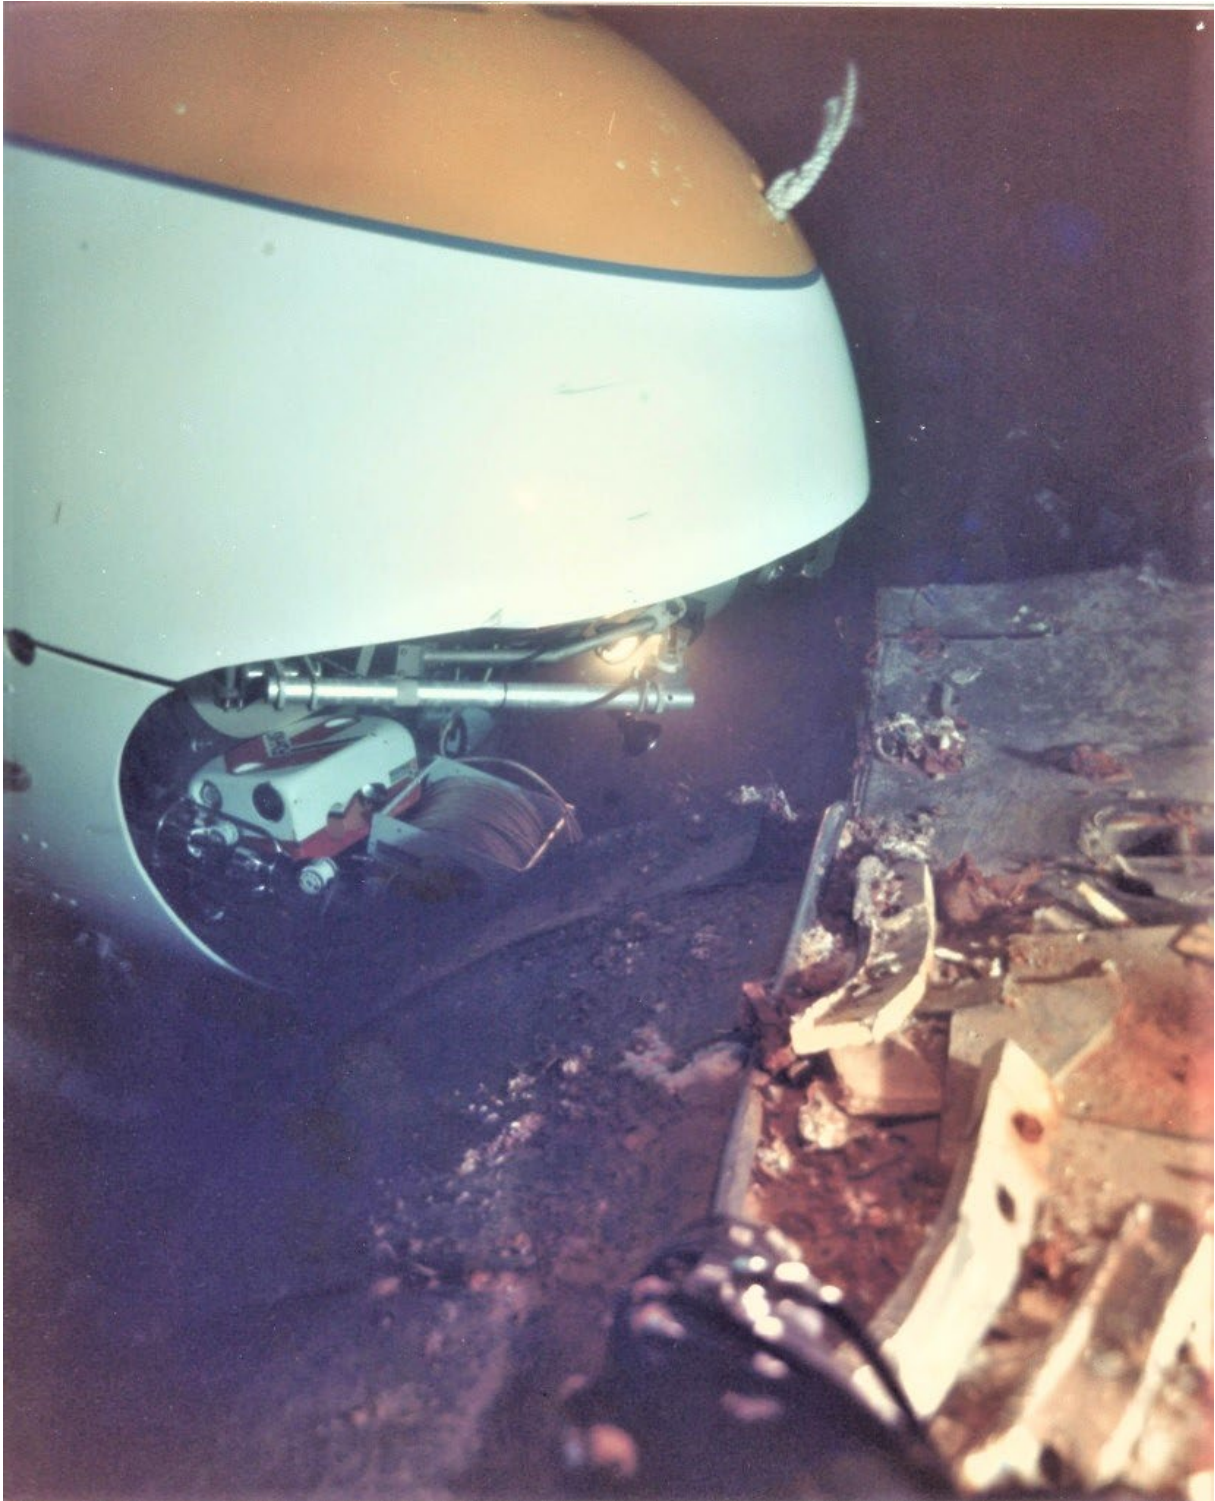
Figure 1.5. Photo showing one of the MIR submersibles investigating damage to the torpedo compartment of Komsomolets during the 1993 Russian investigation. The photo's perspective is taken looking away from the bow of the submarine and shows the starboard side of the torpedo compartment before this area was covered with tarpaulins. (Photo: DSA).

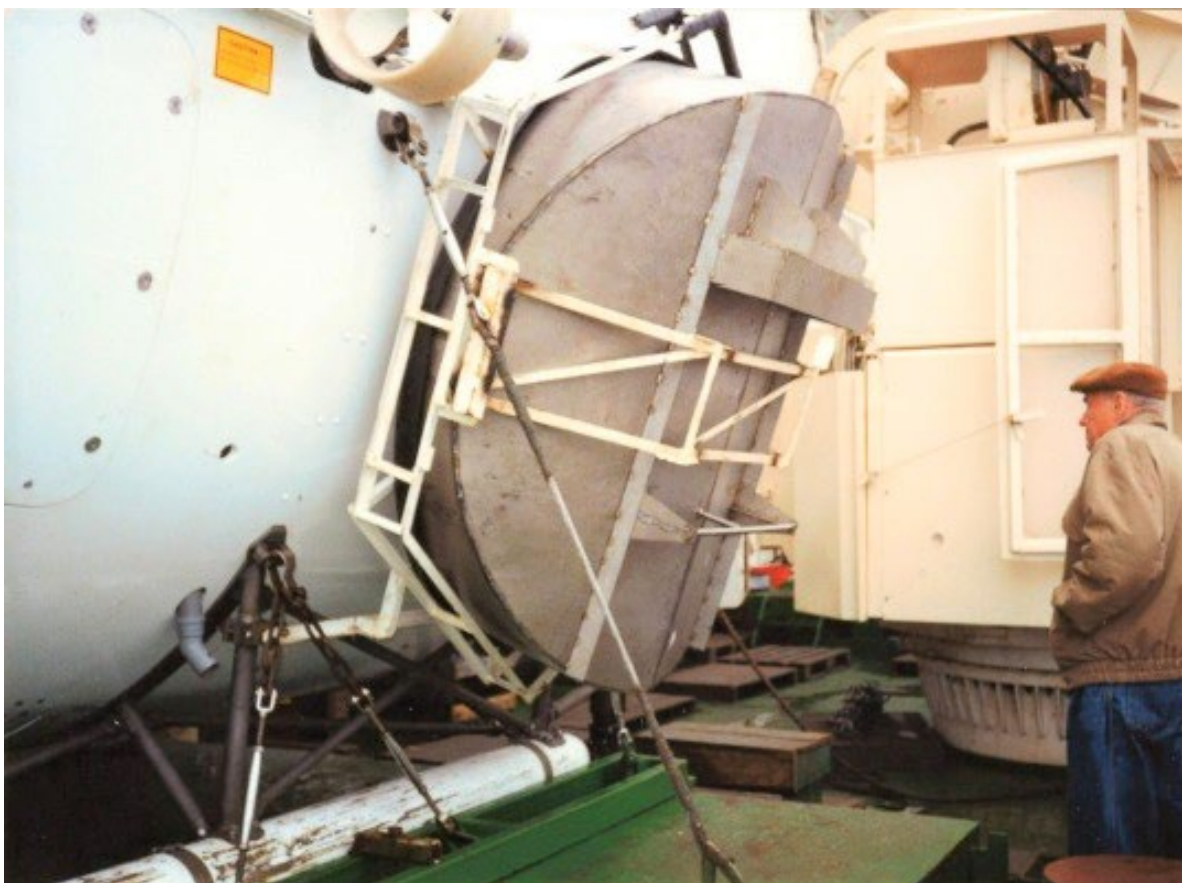
Figure 1.6. Photo showing one of the titanium plugs that was placed over the torpedo tubes by the Russians in 1994. The plug is fastened to the side of one of the MIR submarines used during the 1994 Russian investigation. (Photo: DSA).

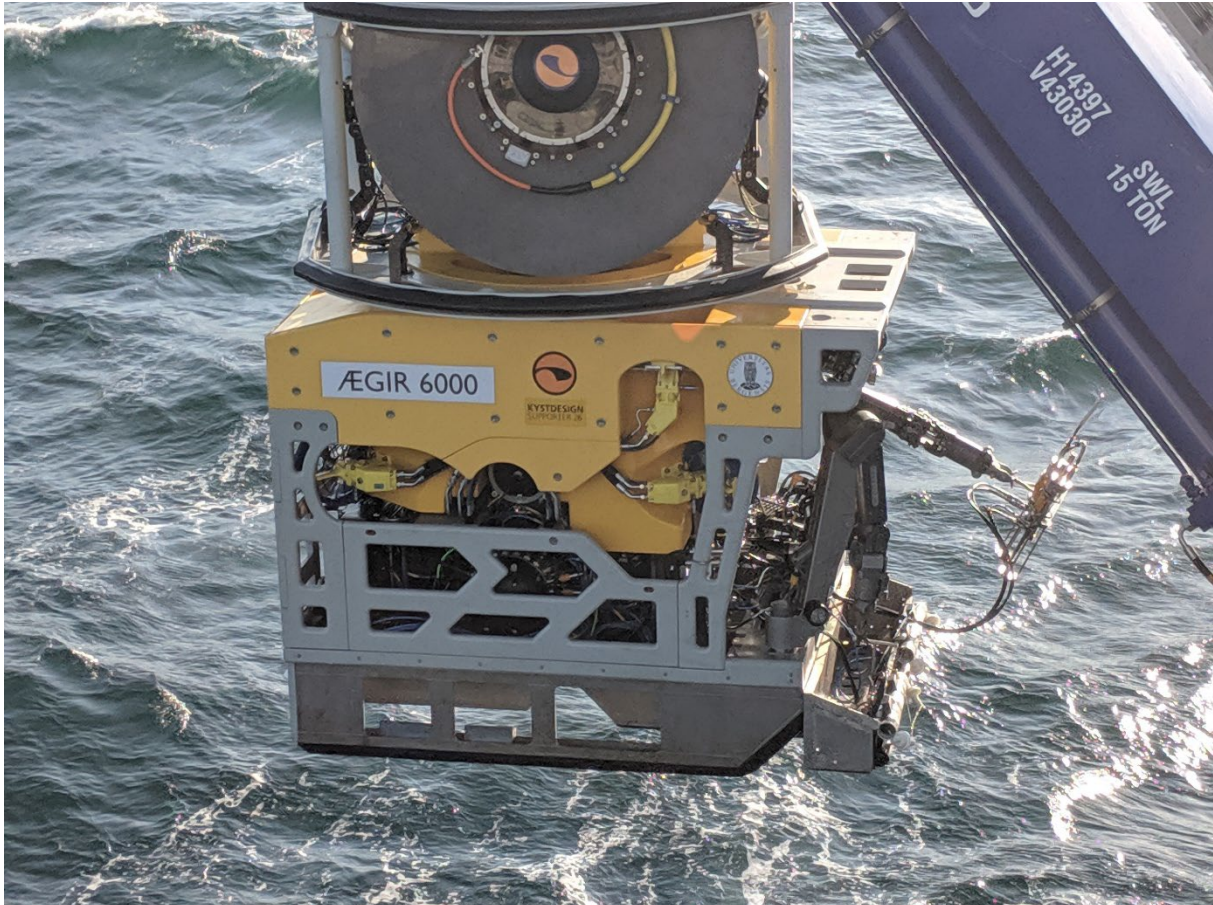
Figure 2.1. The remotely operated vehicle (ROV) Ægir 6000 (Photo: DSA).

All sampling work was conducted onboard the R.V. “G.O. Sars” of the Institute of Marine Research between the 7th and 9th of July 2019. The ROV Ægir 6000 (Fig. 2.1) was used to conduct sonar and video surveys as well as to collect seawater, sediment and biota samples over the course of 4 dives. Independently of the ROV, large volume surface and bottom water samples were also collected.

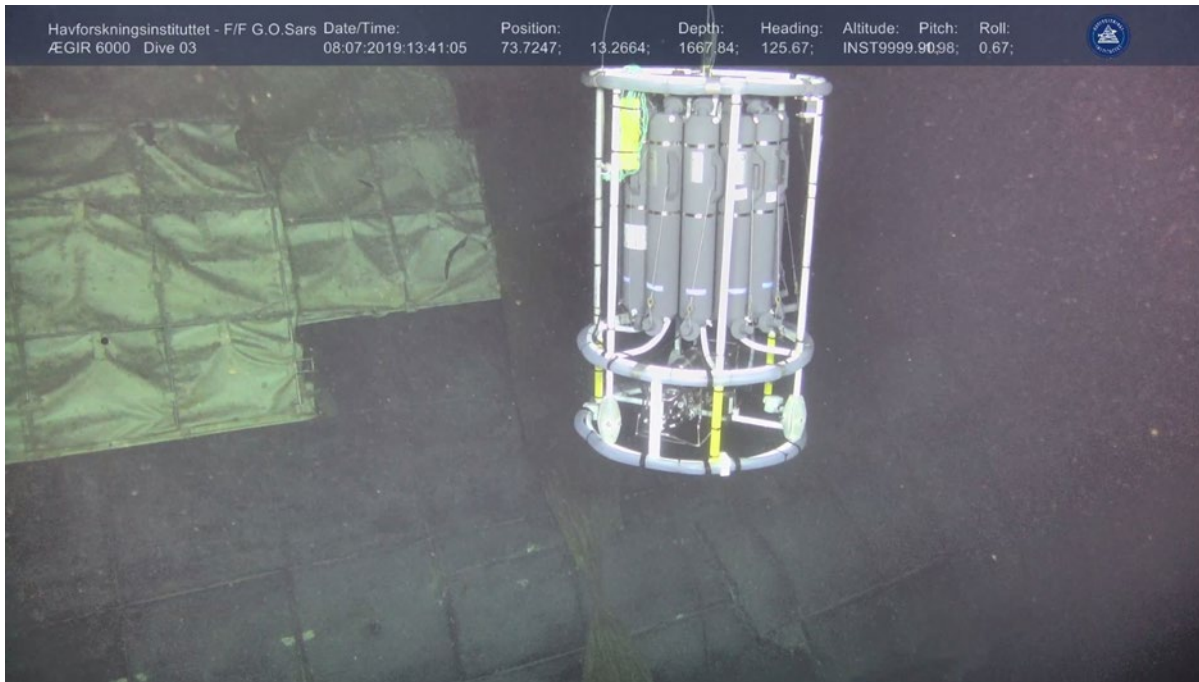
Figure 2.2. Large volume samples collected around 3 m directly over the ventilation pipe (upper photo) and next to the opening in torpedo compartment on the port side of the submarine (lower photo) (Photos: IMR).

beside the torpedo compartment (port side) at two different locations (Fig 2.2). Smaller volume water samples were collected directly by the ROV, using three 1 l syringe samplers and two 2 l Niskin bottles. These samples were collected directly from or close to the ventilation pipe, at various heights above the ventilation pipe and at a distance of approximately 1 m from either side of the reactor compartment (Fig. 2.3). Samples collected directly from the ventilation pipe were taken from a depth of around 20 to 30 cm inside the ventilation pipe.

The large volume bottom samples that were collected beside the torpedo compartment at two different locations was carried out using just one cast of the water sampler, with half of the Niskin bottles on the water sampler used at one location and the other half at the second location. From each of these samples 40 l was taken to determine Pu-239 and Pu-240 and filtered through 0.45 µm membrane filters (Millipore), as was the case for 50 ml samples for trace elements.

c - Torpedo compartment. Figure 2.2. shows this sample being collected.

b - Torpedo compartment. Figure 2.2. shows this sample being collected.

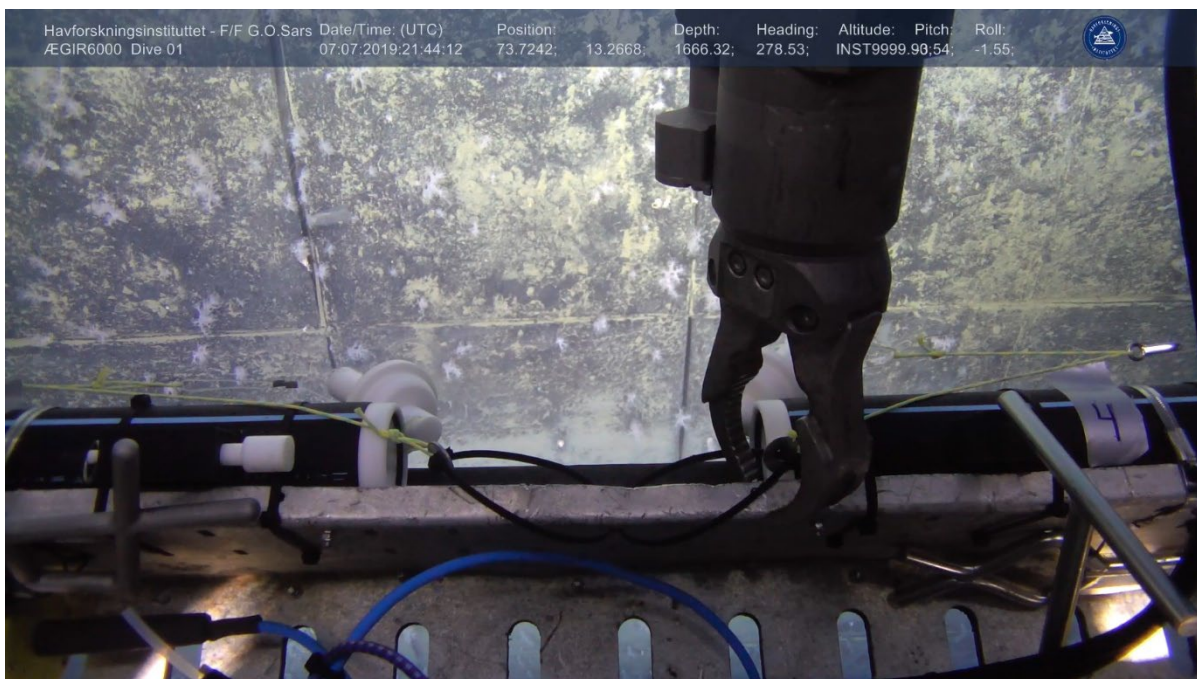
Figure 2.3. Syringe sample collected directly from the ventilation pipe (upper photo) and Niskin bottle sample collected next to reactor compartment (lower photo) (Photos: IMR).

For the small volume samples taken directly by the ROV using syringe samplers and Niskin bottles, these samples were transferred to plastic bottles and then were analysed for gamma emitters directly onboard using a NaI detector before further treatment. One sample (collected above a metal grill next to the ventilation pipe) was filtered through a 0.45 µm filter and reanalysed onboard, but otherwise the samples were stored at 5°C.

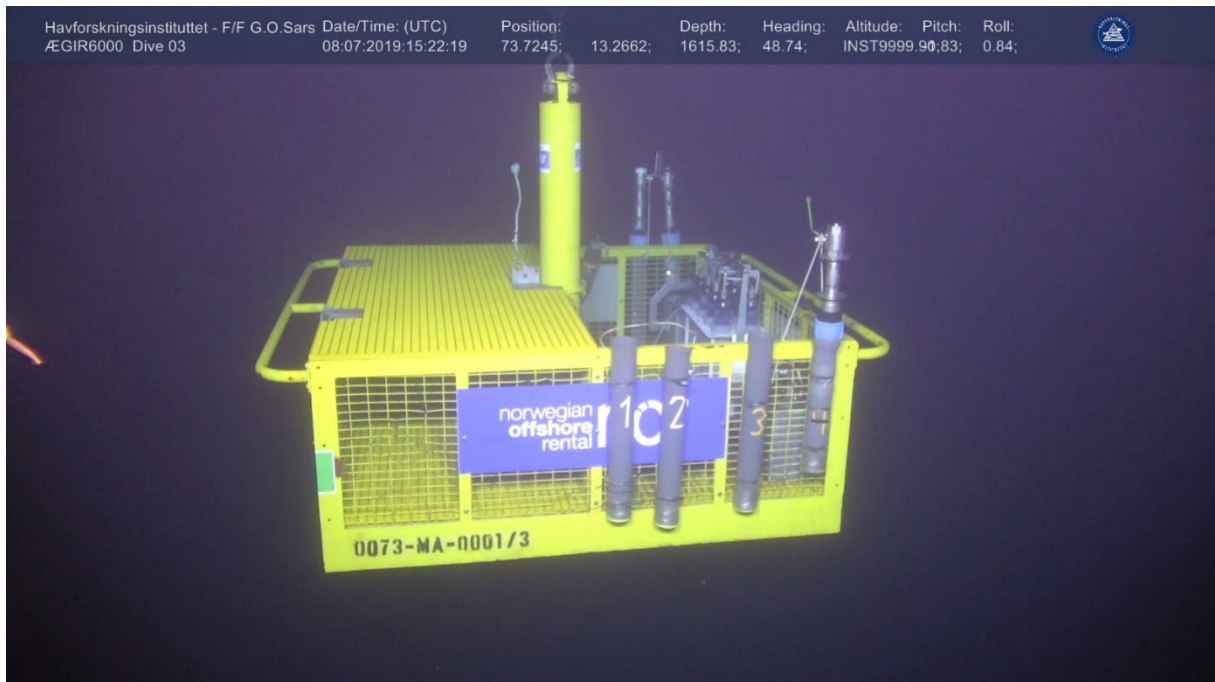
Figure 2.6. Auxiliary basket used in conjunction with the ROV to return sediment samples to the surface (Photo: IMR).

Sediment samples were taken at various locations around the submarine (Fig. 2.4) using either push cores or blade cores (Fig. 2.5 a and b). Push and blade cores with sediment samples were returned to the surface using an auxiliary basket (Fig. 2.6) to allow the ROV to continue operations without surfacing. Onboard, all push core tubes were sealed and then frozen. Surface sediment samples (0 to 2 cm) were taken from blade cores collected from the port and starboard sides of the reactor compartment for screening purposes directly onboard using a NaI detector.

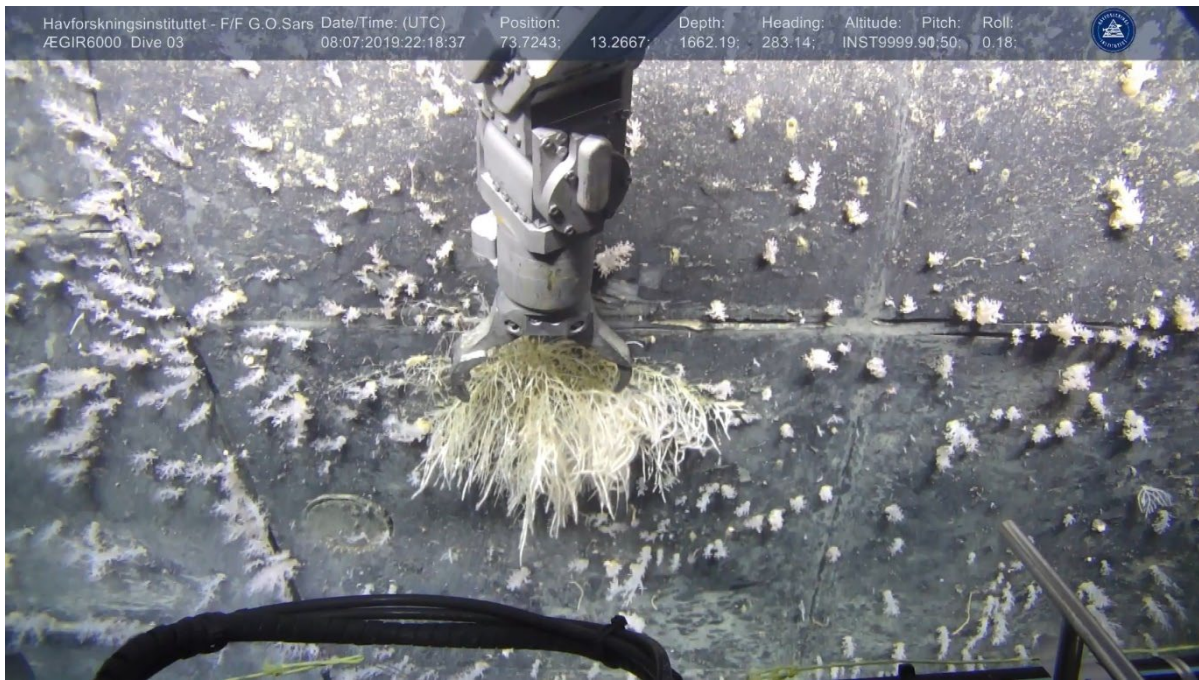
Figure 2.7. Biota sample on hull surface collected using ROV's manipulator arm (upper photo) and biota sample on seafloor collected using ROV's vacuum sampler (lower photo) (Photos: IMR).

Biota samples were collected from hull surface below the ventilation pipe and from both the port and starboard sides. One biota sample was collected directly from the seafloor and next to the hull of the submarine. Samples were collected using either the manipulator arm or a vacuum sampler (Fig. 2.7). Onboard, biota collected were roughly sorted into similar types and then frozen.

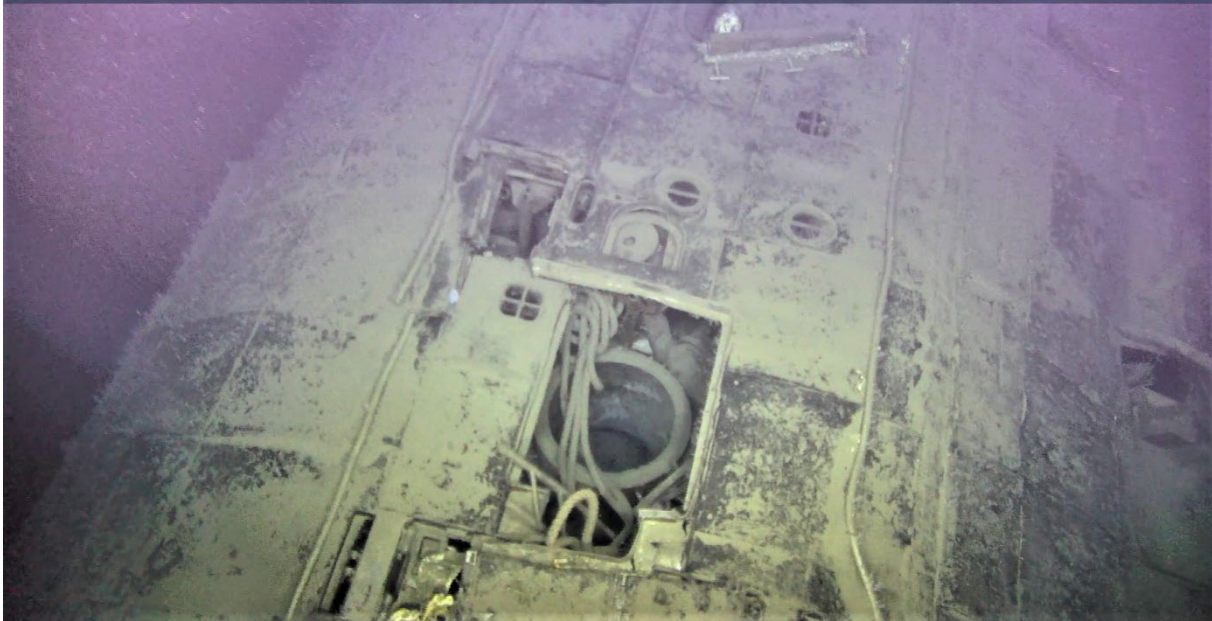
Figure 4.11. Close up view of the forward entrance hatch that led to the torpedo compartment. The outer hatch and coaming were missing, but it was not possible to determine whether the inner hatch was open or closed (Photo: IMR).

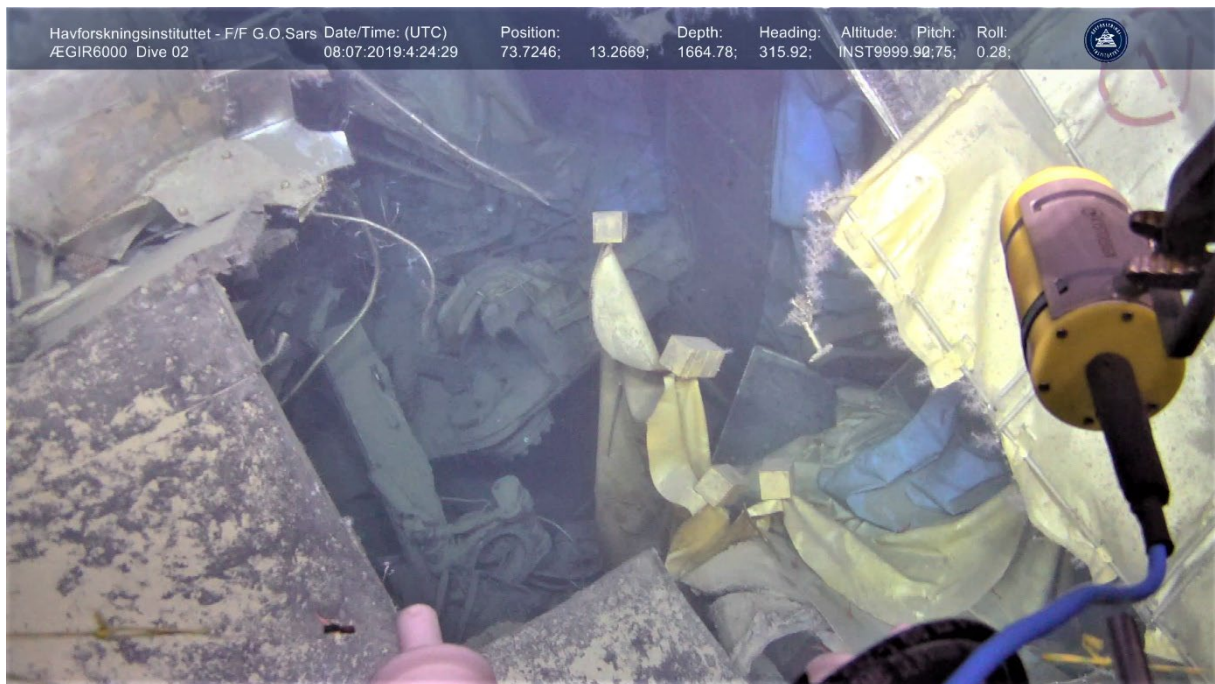
Figure 4.14. View down into the opening in the outer and inner hulls seen in Figure 4.13. The blue and yellow objects are part of the material that was packed into the torpedo compartment during the Russian investigation to Komsomolets in 1994. The yellow instrument in the ROV's manipulator arm is a Geiger counter (Photo: IMR).

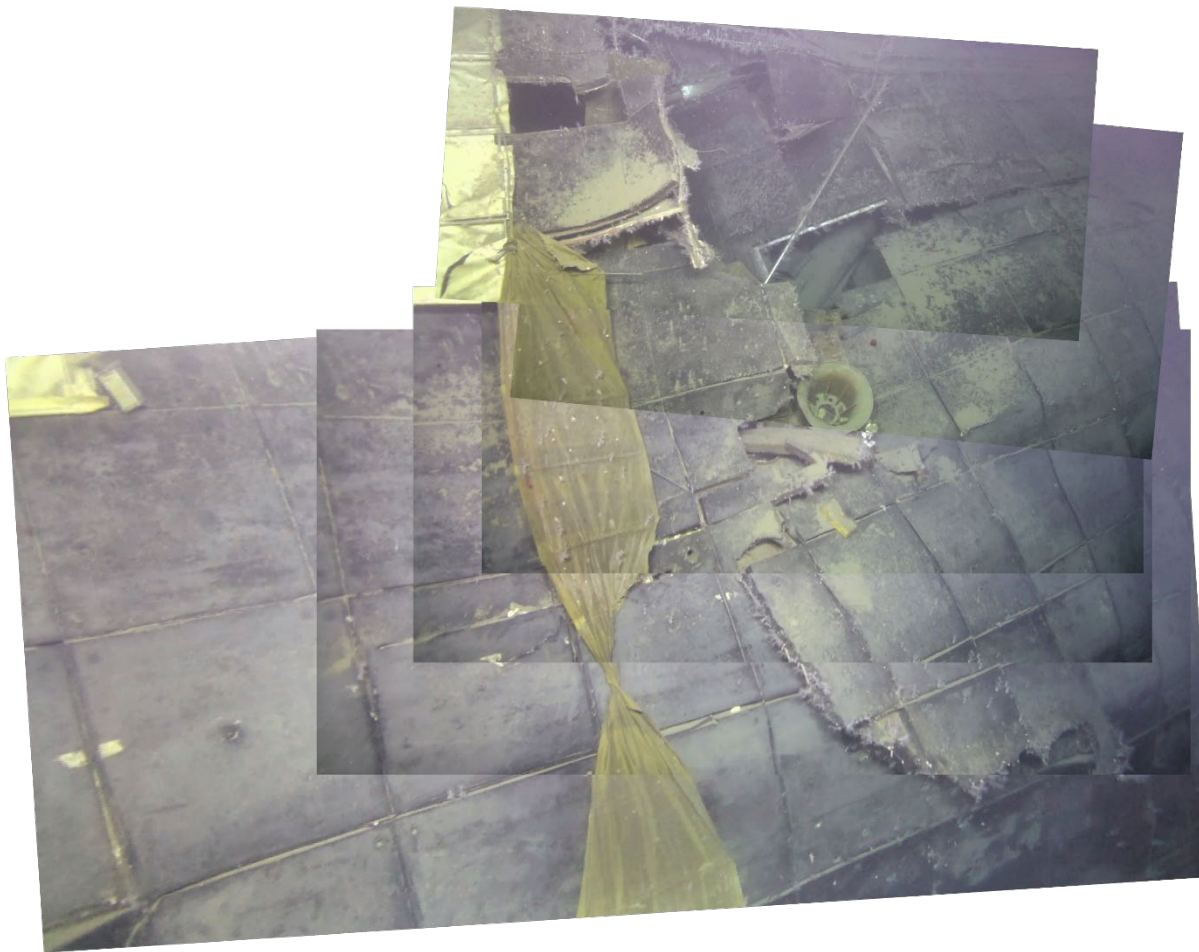
Figure 4.15. Damage to the outer hull on the port side below the opening in the upper deck shown in Figure 4.13. (Photo composite: DSA/IMR). Red frame on the plan drawing of Komsomolets shows the relative position of the image above.

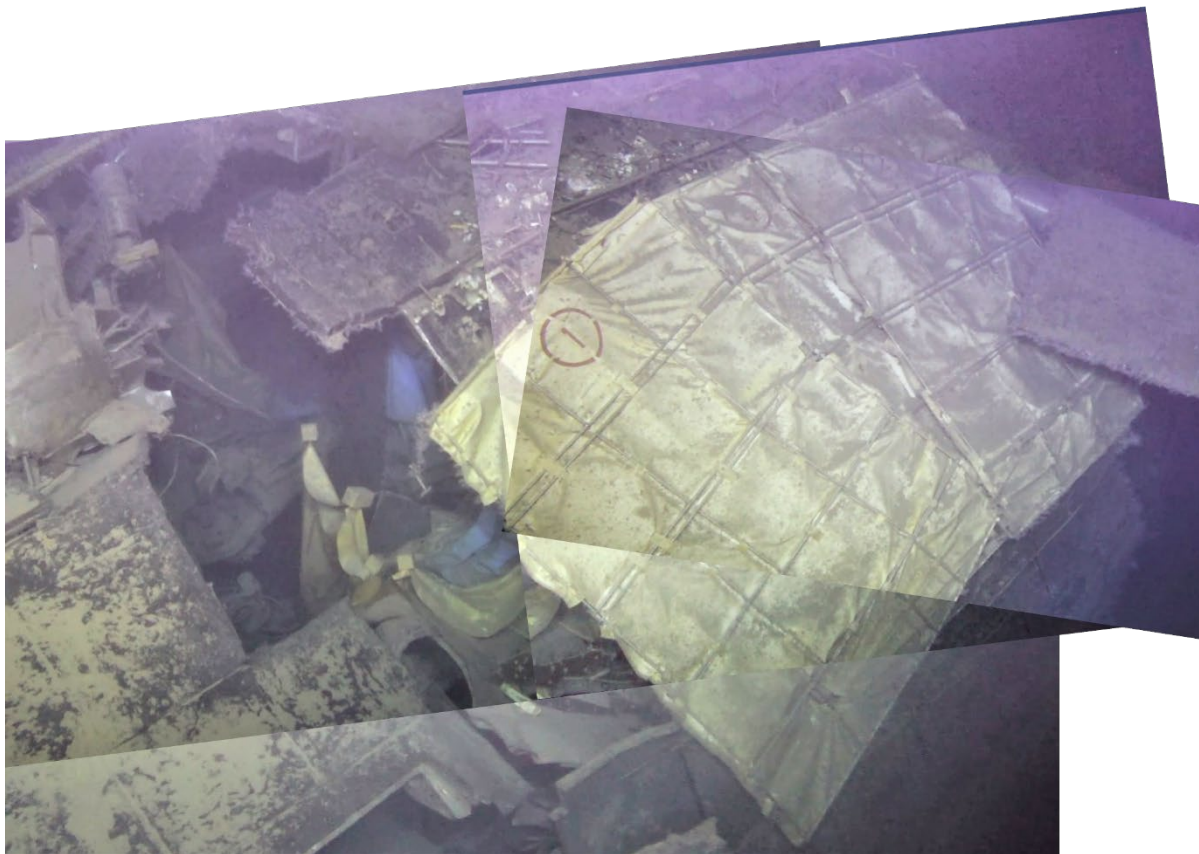
Figure 4.16. View of the coverings installed over the starboard side of the torpedo compartment by the Russian investigation to Komsomolets in 1994 (Photo composite: DSA/IMR). Red frame on the plan drawing of Komsomolets shows the relative position of the image above.

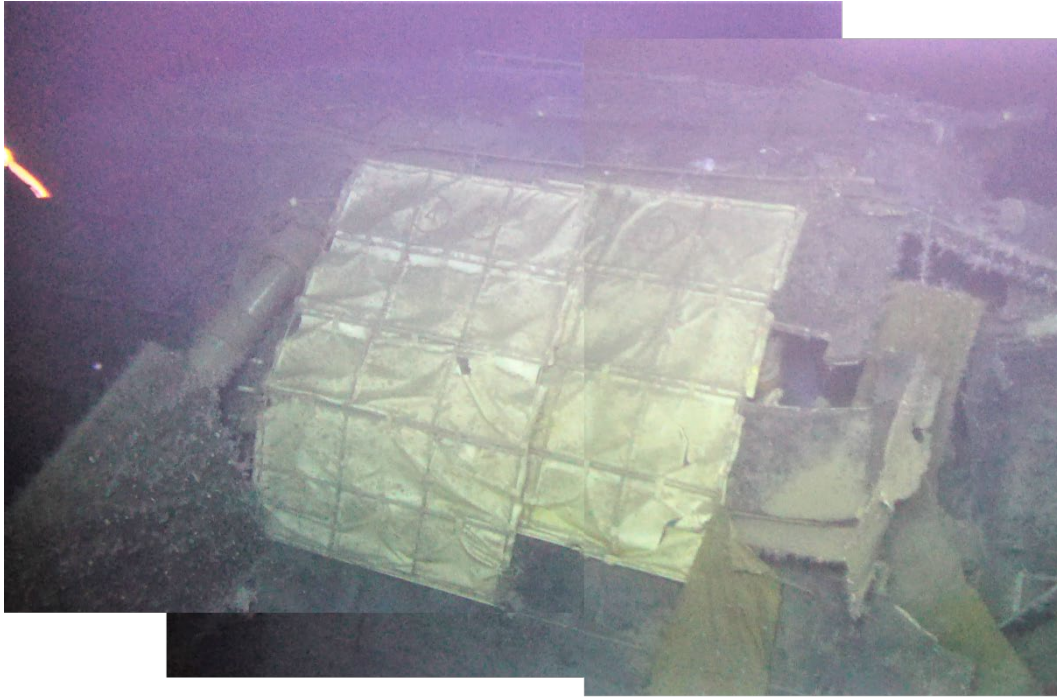
Figure 4.17. View of the coverings installed over the port side of the torpedo compartment by the Russian investigation to Komsomolets in 1994 (Photo composite: DSA/IMR). Red frame on the plan drawing of Komsomolets shows the relative position of the image above.

The outer hull plates along the port and starboard sides of the submarine below the forward entrance hatch have been deformed so that the aft edge of the hull plates have been forced inwards (Figure 4.12). A wide and horizontal jagged opening in the outer and inner hulls can be seen across the entire upper deck over the torpedo compartment (Figure 4.13). This opening was partially filled with various material during the 1994 Russian investigation (Figure 4.14). Obvious deformation damage can be seen to the outer hull down both the port and starboard sides of the submarine that extend from the jagged opening in the upper deck (Figure 4.15). Beyond the jagged opening in the upper deck, the port and starboard sides of the torpedo compartment are still covered by the coverings that were also installed in 1994 (Figure 4.16 and 4.17). These coverings likely cover the cracks in the outer and inner hulls along the sides of the torpedo compartment that were reported by Yablokov et al. (1993). Furthermore, it was possible to see several titanium plates on the upper deck over the torpedo compartment that were placed over smaller openings in 1994 (Figure 4.18).

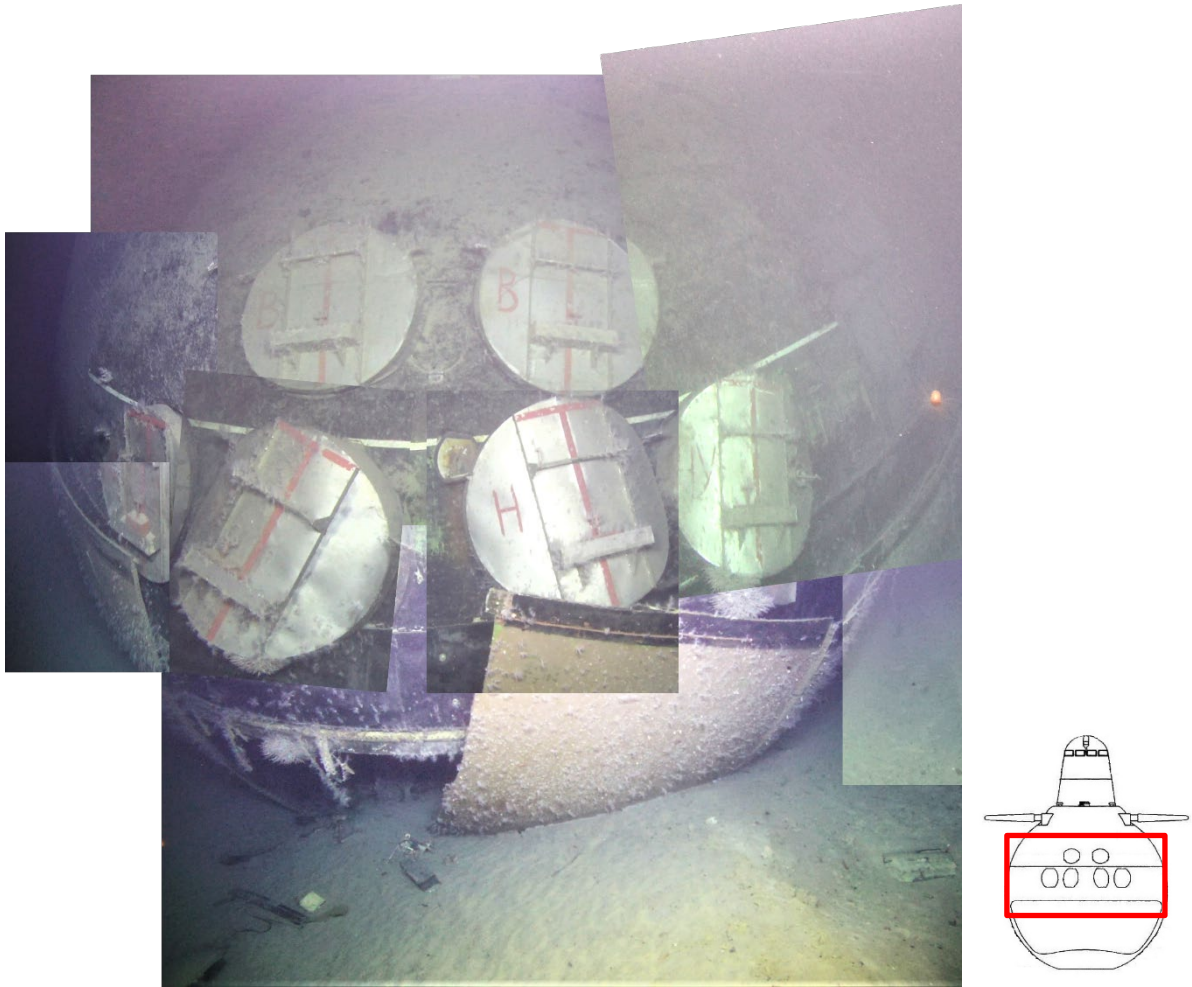
Figure 4.20. View of the bow of Komsomolets showing the plugs installed over the six torpedo tubes by the Russian investigation to Komsomolets in 1994 and the damage to the lower outer hull (Photo composite: DSA/IMR). Red frame on the plan drawing of Komsomolets shows the relative position of the image above.

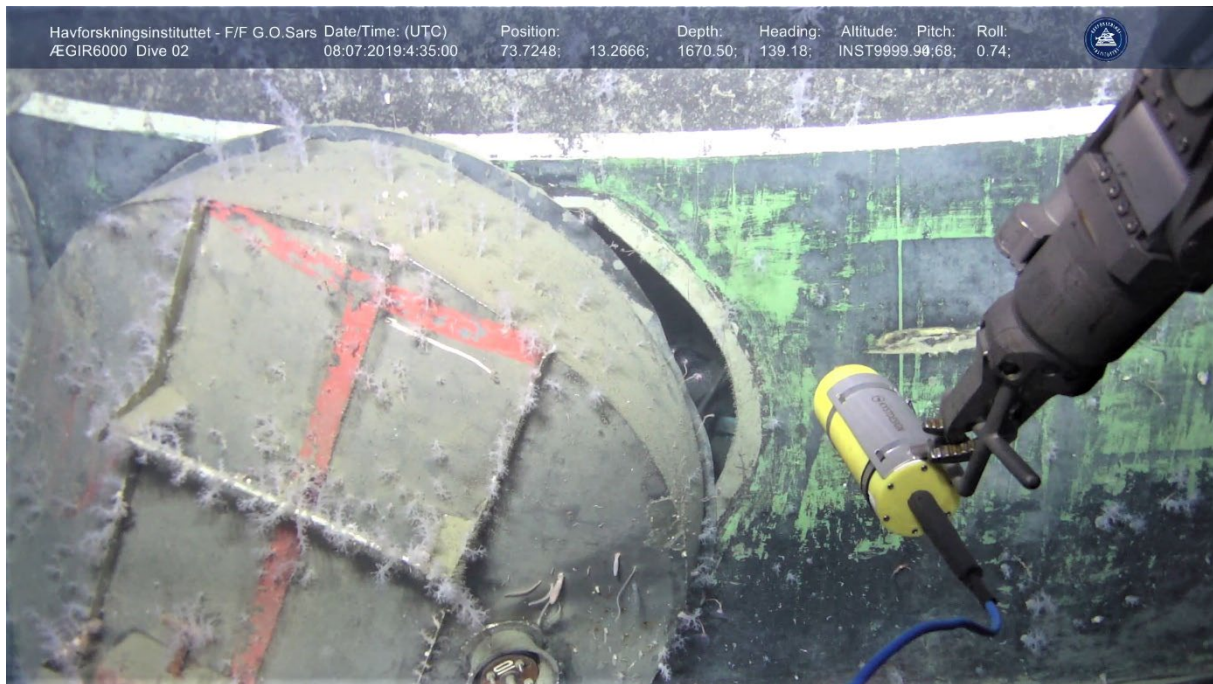
Figure 4.21. Close up view of one of the plugs installed over a torpedo tube by the Russian investigation to Komsomolets in 1994, showing that the torpedo tube in this instance is not entirely covered. The yellow instrument in the ROV's manipulator arm is a Geiger counter (Photo: IMR).

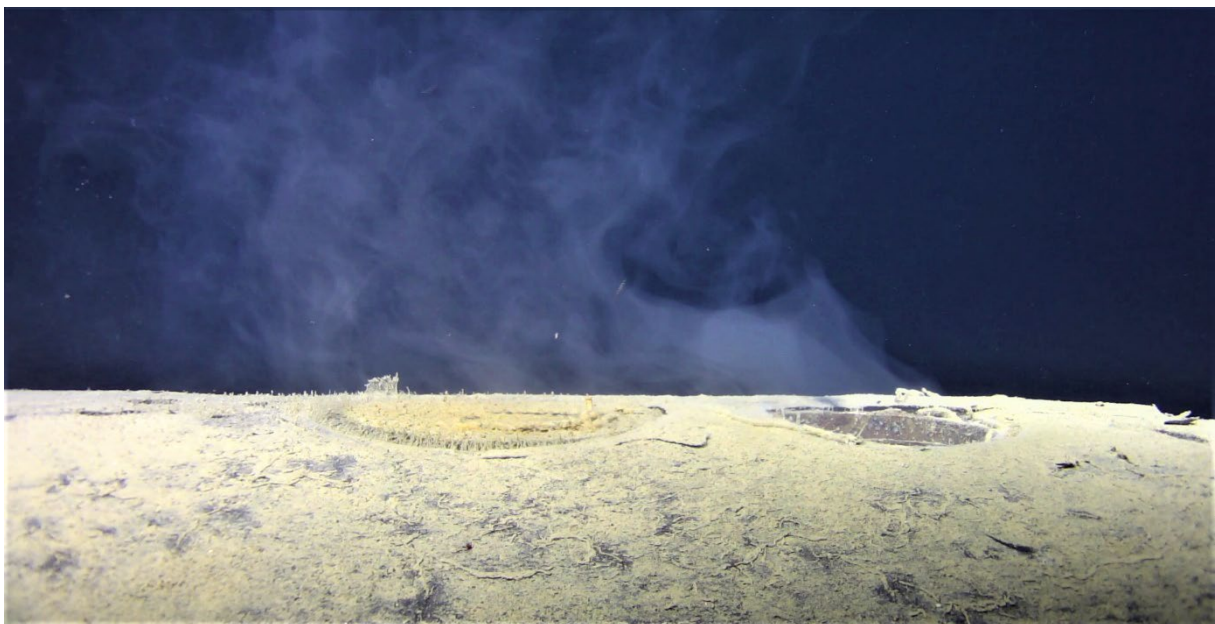
Figure 4.24. Close up view (port side) of the visual release coming out of the ventilation pipe and the particulate material accumulated on the hull surface at this location (Photo: IMR).

Releases of radionuclides from Komsomolets have been detected previously by in situ measurements in a ventilation pipe that forms an open connection between compartment five, aft of the reactor compartment, and the open sea (Nejdanov, 1993; Gladkov et al., 1994; Kazennov, 2010). This ventilation pipe was located on top and at the back of the sail, aft of the last antenna bay (Figure 4.23). Initial visual observations of the ventilation pipe during the first dive of the ROV did not reveal anything unexpected, although there was an obvious accumulation of particulate material on the upper hull surfaces of this section of the sail and around the ventilation pipe (Figure 4.23). However, during the subsequent three dives with the ROV an obvious visual release could be seen coming out of the ventilation pipe that appeared to vary in intensity (Figure 4.24). From the available published information on the various Russian investigations to Komsomolets, there has not been any mention of such a visual release from the ventilation pipe, however such a visual release can be briefly seen from video footage taken by one of the MIR submersibles during a previous Russian investigation. In addition to the visual release from the ventilation pipe, a similar release was observed on some occasions emerging from the metal grill immediately forward of the ventilation pipe (Figure 4.25) and at times from both the ventilation pipe and the metal grill simultaneously (Figure 4.26). Releases of any kind from this metal grill have not been reported by any previous Russian investigation. Based on available schematics of Komsomolets, it is possible that the pipe under the metal grill is the air inlet for the diesel generator in compartment three, immediately forward of the reactor compartment. However, it is not known whether there is any connection or opening between the ventilation pipe and the pipe covered by the metal grill either by design or as a result of the accident and/or subsequent corrosion that would allow releases to pass from one pipe to the other. As is likely the case for the ventilation pipe, the air inlet pipe for the diesel generator would have been open when Komsomolets sank as it was reported that the diesel generator in compartment three was in operation at the time of sinking (Romanov, 2006). No obvious visual releases were observed emerging from any other opening around the submarine during any of the dives with the ROV. When visual releases were observed, these tended to drift slowly towards the bow of the submarine (i.e. northwards).

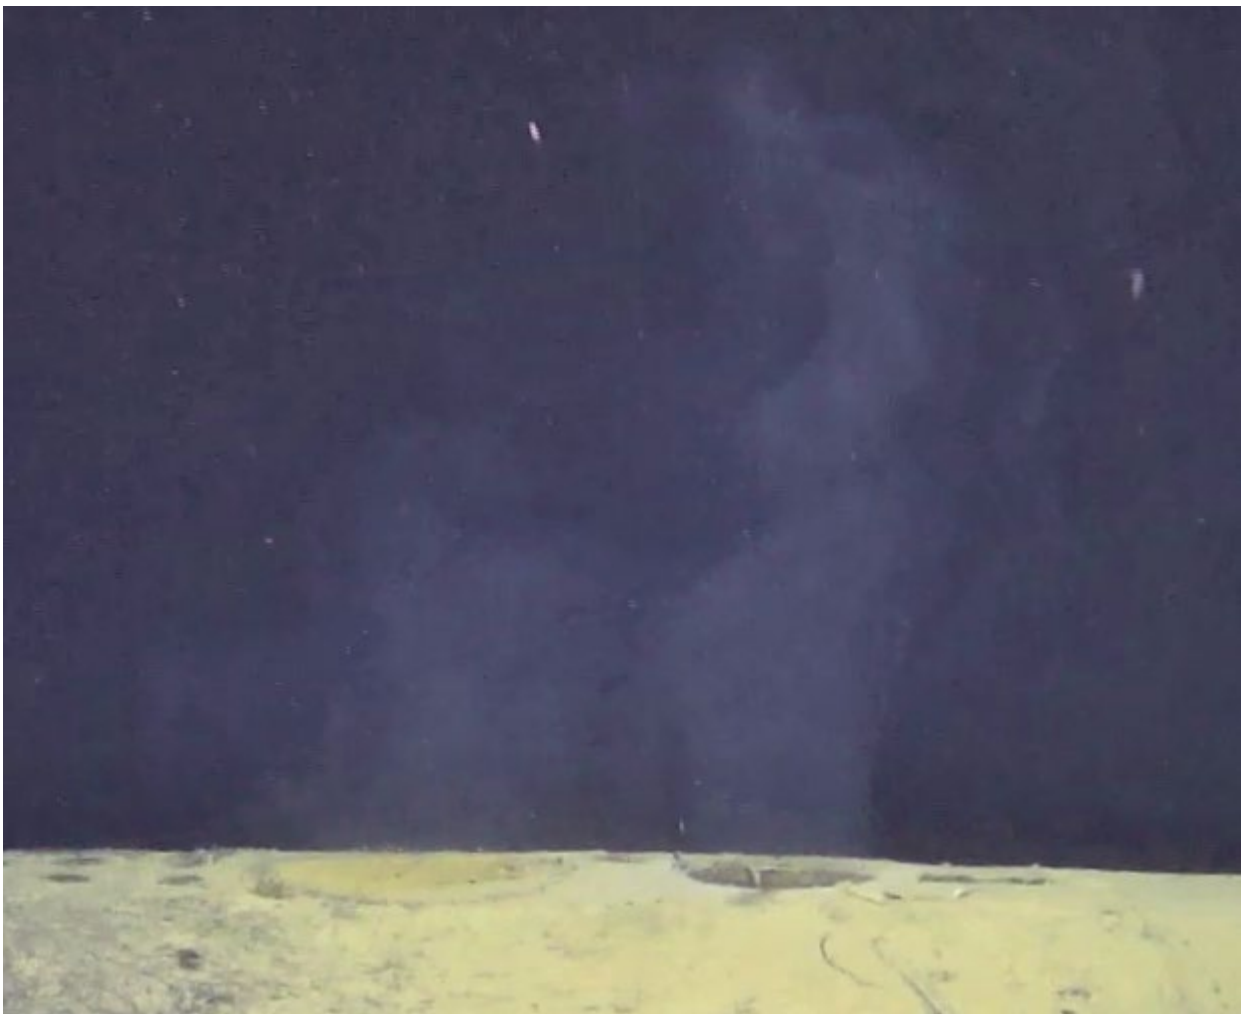
Figure 4.26. Close up view (port side) of the visual release coming out of the ventilation pipe and the metal grill at the same time (Photo: IMR).

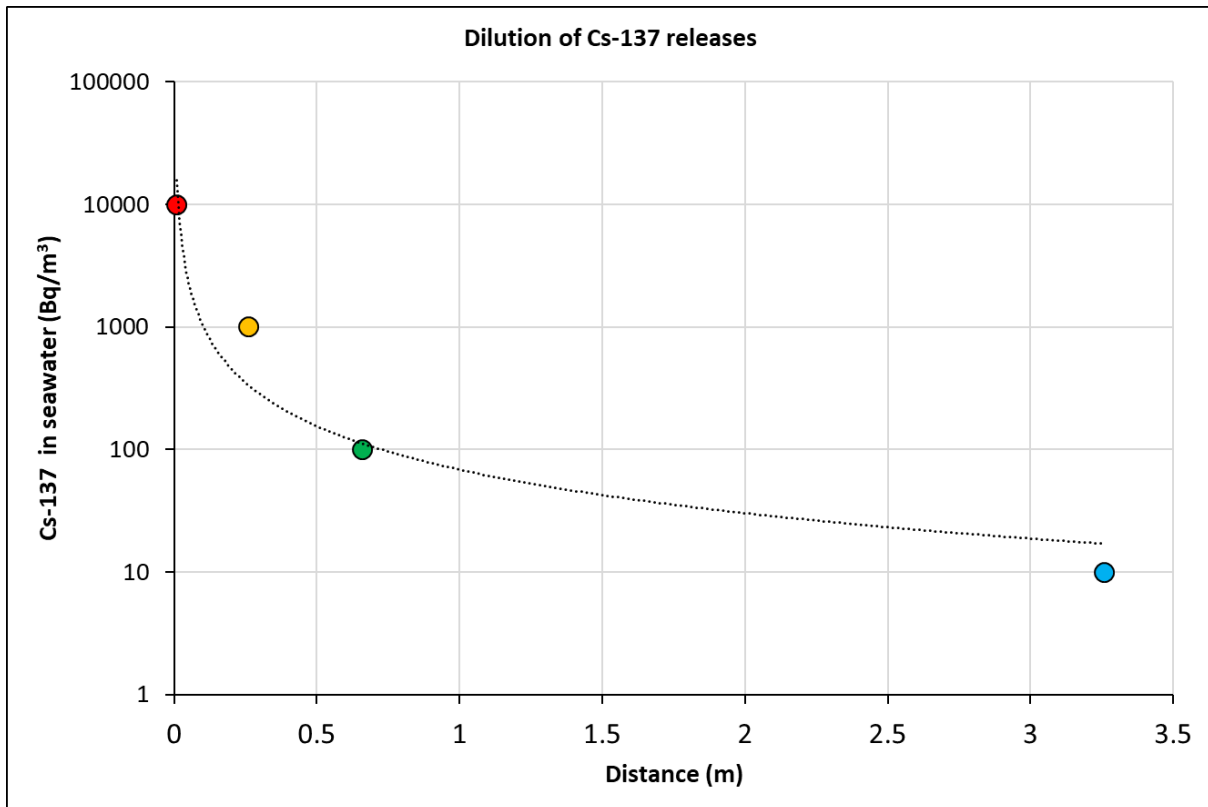
Figure 4.30. Estimated rate of dilution of Cs-137 releases based on the magnitude of Cs-137 activity concentrations (Bq/m³) in filtered seawater at different distances from the release point. The red dot represents samples taken directly from ventilation pipe at an assumed depth of 25 cm within the pipe. The orange dot represents the sample taken next to the ventilation pipe (assumed distance of 1 cm). The green dot represents samples taken 40 cm over ventilation pipe. The blue dot represents the large volume sample taken 3 m over the ventilation pipe, with a magnitude based on the theoretical value derived for second cast. For use in the figure above, the first data point is set to 0 m, and all other data points shifted by 25 cm to take into account the assumed sampling depth inside the ventilation pipe.
